MARYLAND HISTORICAL TRUST
NR-ELIGIBILITY REVIEW FORM

Property Name: Bridgeport Survey District Inventory Number: F-6-89

Project: Bridgeport, Nextel Cell Tower MD-2259 Agency: FCC

historic Bridgeport Survey District

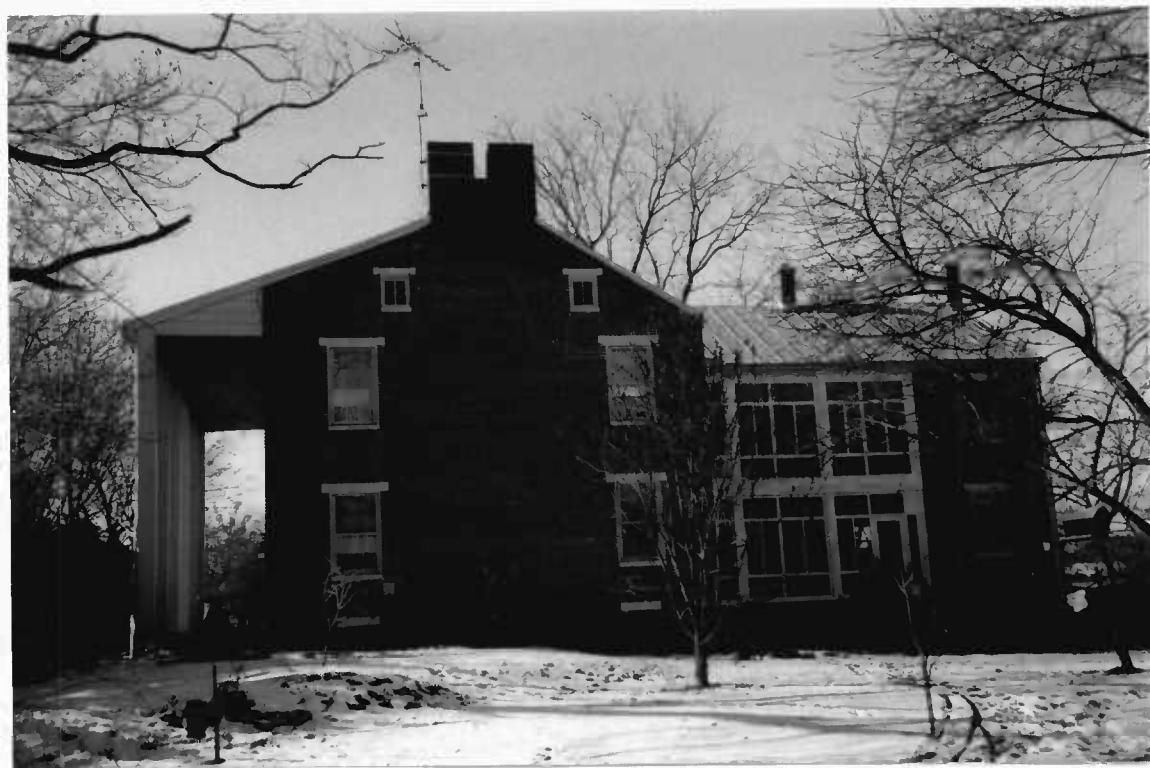
1/8

Christian Correll Tavern

(2) The Christian Correll Tavern is located at 12240 Taneytown Pike, Bridgeport, MD. It is a two-story building with common bond brickwork resting on a stone foundation and is an example of large and elaborate I-House construction. According to its owner who lives there, Mr. Makosky, the Christian Correll Tavern was constructed in 1830. The façade of the side-gable main

section faces south. It is five bays wide and two bays deep. Two-stack chimneys are flush at both gable ends. A rear two-story ell contains a three-quarter wide recessed two-deck porch. It contains two chimneys, one flush at the north gable end, and one internal midway at the peak. The rear ell is also configured five-by-two bays in area. Intended as a tavern and inn, the building's interior was divided into a number of small rooms. Later, walls between some of the rooms were torn out. Other developments mitigate against recommending placing the tavern on the National Register of Historic Places. The main façade has six square columns that replace the original full width two-deck open porch. Likewise, the open two-deck porch on the rear ell also has been compromised. It is currently contained behind a modern enclosure of wood frame and glass.

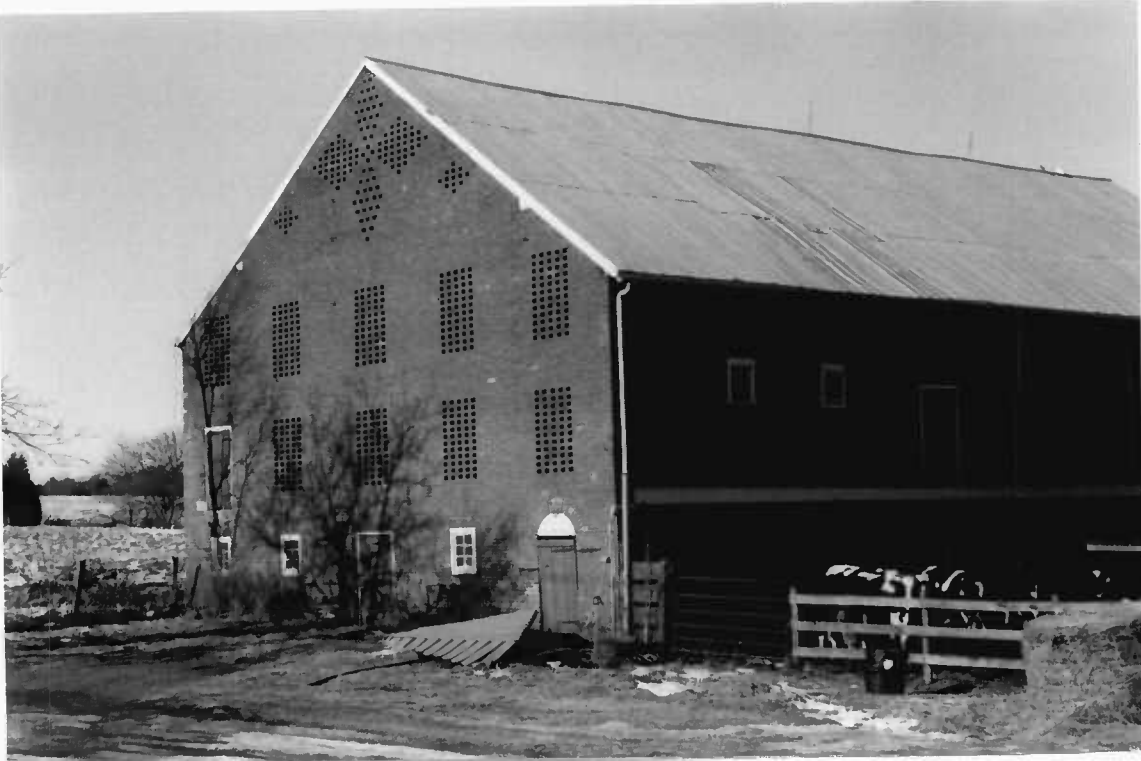
2/0

Christian Correll Barn

The Christian Correll Brick Bank Barn is located to the west of the tavern. This brick-end bank barn rests on a stone foundation. The gable roof of corrugated tin runs north to south. The banked elevation is on the west. The east elevation has a weatherboarded jetty overhang. On the ground level, stall openings are placed between brick piers. The south gable end, facing the road, is the most decorative facade. It has flemish bond brickwork and

patterned ventilation. There is "unfolding lily" pattern and two diamonds beneath the gable peak and square ventilators in the center. Windows have jack arches; one door has a rounded arch.

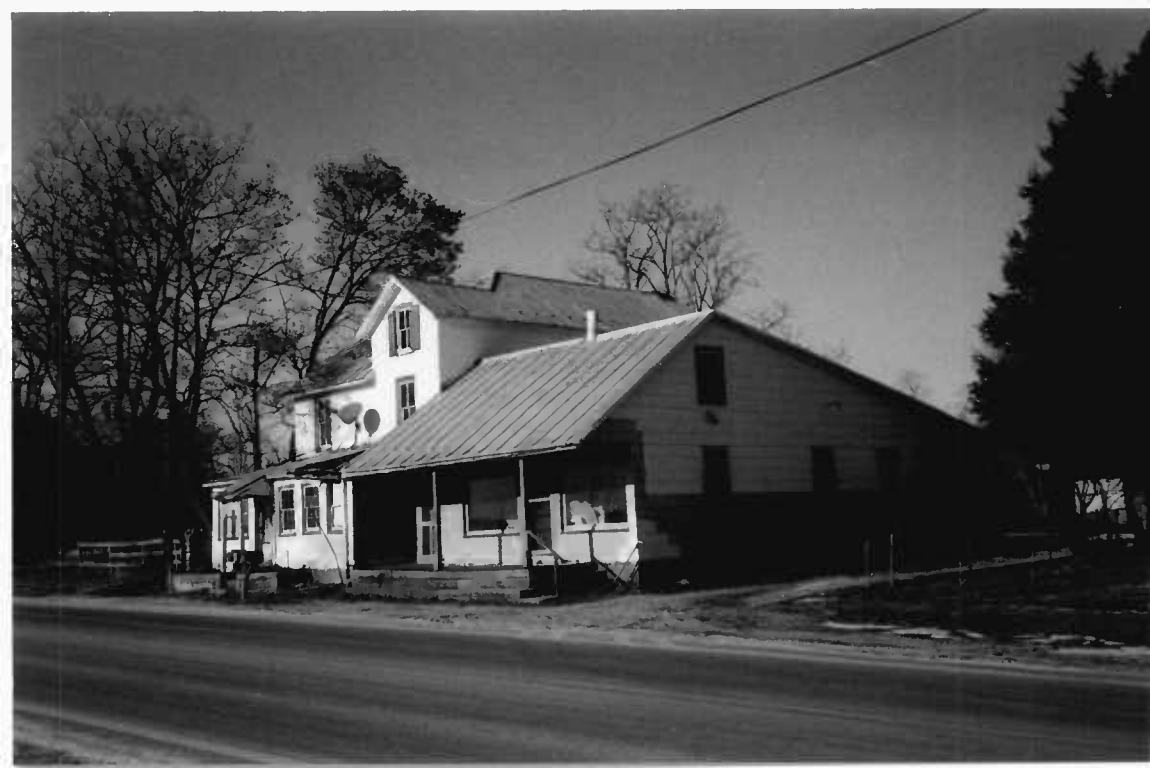
3/8

Post Office and General
Store

(3) The Post Office and General Store is located at 12306 Taneytown Pike, Bridgeport, MD. It is a commercial and residential building constructed in multiple stages. There are two attached main buildings and one addition. The oldest block is two stories high with a chimney at the west gable end. It appears to have been built approximately in the mid-nineteenth century. According to Mr. Makosky, owner of the adjoining property containing the Christian Correll Tavern and Bank Barn, the old section is constructed from logs. The gable-sided building faces south. The building appears to be three bays wide and two bays deep. An enclosed porch with a half-hip roof spans the full-width of the south elevation. A rear ell extends on the north side. It is two-by-two bays in configuration. A one-story addition with a cinder block chimney extends from the rear ell northward. Built approximately during the mid-nineteenth century, this vernacular frame has Greek Revival details seen in its pedimented windows and the cross-gabled section one bay wide extending from the roof and raising the south façade, like a huge dormer, suggesting a third floor. The older block is clad in asbestos shingles. The second block is attached to the east elevation of the oldest block. Its main façade faces south. This one-and-one-half-story is two bays wide and one bay deep with a saltbox extension. This portion of the building probably contained the post office and general store, although these facilities originally may have served the public from the old section as indicated in an 1873 map that depicts them in this location. A number of elements found in this structural composition mitigate against recommending it for inclusion in the National Register of Historic Places: the original block is clad in asbestos shingles, as is the enclosed porch; the gable-end chimney in the rear extension has been removed; a one-story addition erected during this century extends from the rear ell; there currently is a satellite antenna on the porch; and the saltbox building attached to the east elevation was constructed approximately 100 years after the original old section.

12306 Taneytown Pike, formerly the post office and general store, is situated several yards east of the tavern complex. It is a building comprised of two sections. One section is 2 stories shingled in asbestos and a gable roof of corrugated tin. It also has a intersecting gable on the side on the main elevation. It has one interior end brick chimney. The other section is one story also shingled in asbestos with a gable roof of standing seam tin.

The main elevation of the first section has an enclosed hipped roof porch covering the first floor. Windows in the enclosed porch are 6/6 with plain surrounds. The door opening is off-center. Windows on the second floor and beneath the intersecting gable peak are 2/2 with segmental arches. The second section has four bays with two doors and two picture windows. It is covered with a full facade open porch with square columns. The east elevation shows a saltbox roofline for the one story section.

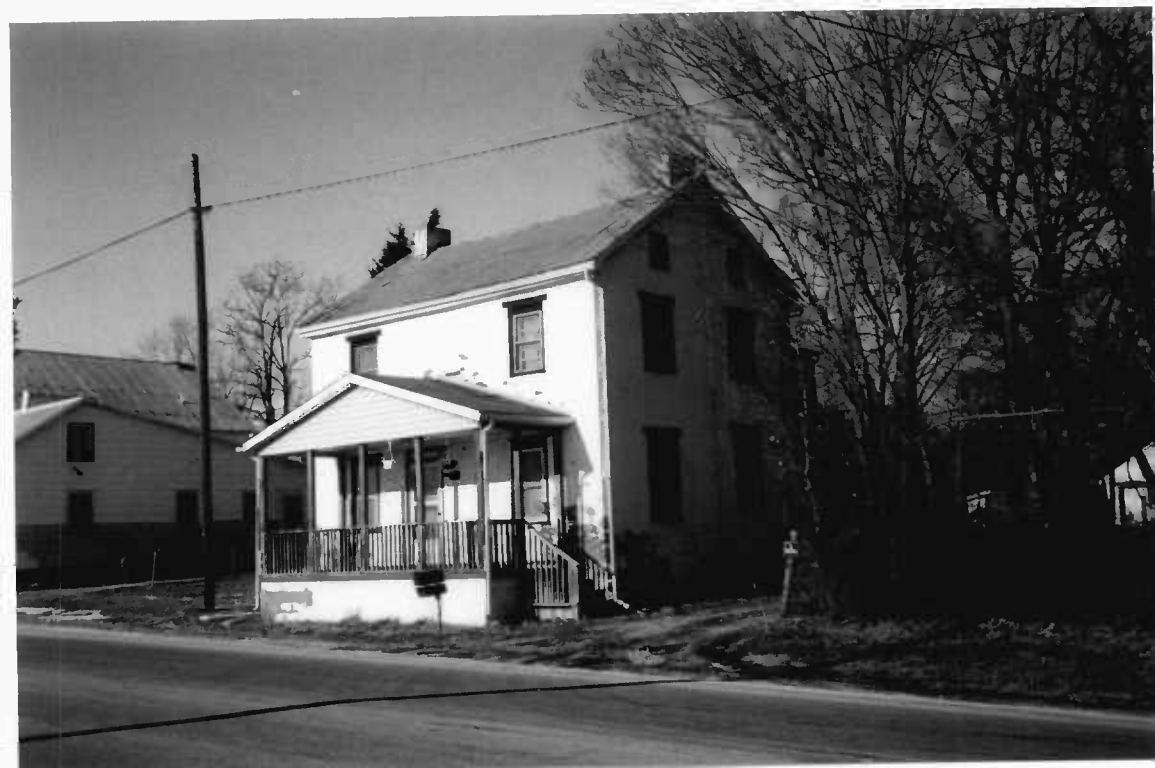
4/8

Blacksmith Shop

(1) The Blacksmith Shop is located at 12310 Taneytown Pike, Bridgeport, MD. It is an I-House built in the mid-nineteenth century. The building with running bond brickwork rests on a stone foundation. There are chimneys at each gable end. A modern gable-roofed open porch spans three-quarters of the main façade. The building consists of a two-story main block with a two-story rear ell as well as two one-story additions on the rear elevation. The main block is a modest I-House three bays wide and two bays deep. The brick walls are painted white. One of the rear additions is constructed in concrete and the other is covered in aluminum. It is conceivable that the blacksmith shop was located in the aluminum-clad addition. Elements that compromise its integrity and render this structure ineligible for the National Register of Historic Places are: the addition of a modern porch on the front façade; the replacement of a window with sliding doors in the rear addition; and the addition of a one-story concrete extension on the rear.

12310 Taneytown Pike, originally a blacksmith shop, is several feet to the east of the post office and general store. It is a two story running bond brick building. The gable roof of corrugated tin has two interior end brick chimneys. The building rests on a stone foundation. There is a two story rear ell, a one story concrete addition and a one story aluminum sided addition extending off the north elevation.

The main (south) elevation has three asymmetrical openings on the first floor with two 6/6 windows and an off-center door. The second floor has two 6/6 windows with flat wood lintels. A new front gable roofed porch covers the facade. The east and west gable ends have 6/6 windows and two 4 light fixed attic windows.

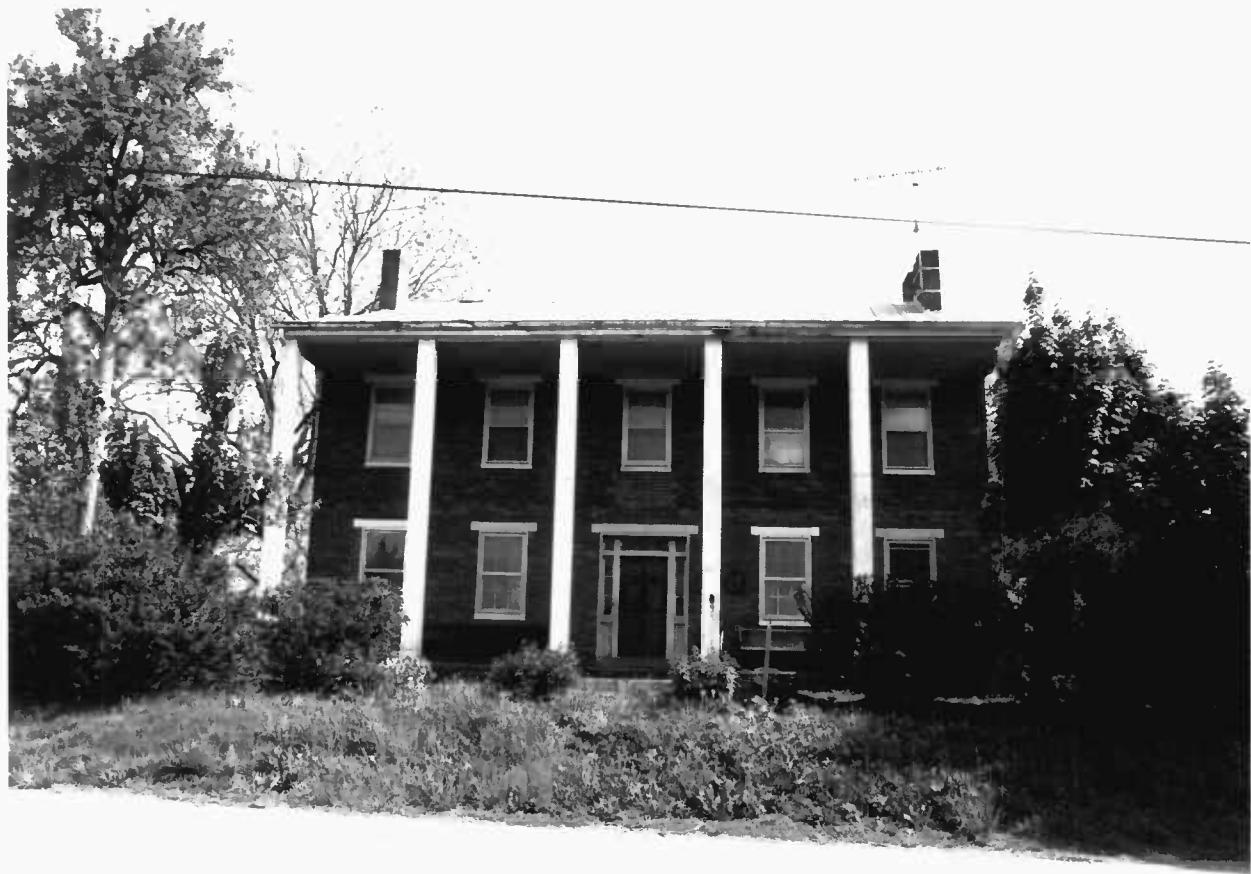
Salin elevation

The Christian Correll Tavern, 12240 Taneytown Pike, is a two story brick building with the principal facade facing south. Constructed circa 1830, the tavern has 6:1 common bond brickwork and rests on a stone foundation. The gable roofline of standing seam tin has a double stacked chimney on each gable end. A two story brick rear ell, also 6:1 common bond, extends off the north elevation. It has a gable roof of corrugated tin with two brick chimneys. The cornice is dentilled.

The main (south) elevation has a 5 bay facade with a center entrance. The door opening has corner block lintels, sidelights and a transom. Windows are 6/6 with corner block lintels. A "southern colonial style" open porch is full facade width and full height. The porch has a stone foundation and a brick floor. The north elevation is covered by the rear ell except for one bay which has a 4/1 window on the first floor and a 6/6 window on the second floor. A door to the cellar is in the foundation level. There are random glazed headers in the brickwork. The west gable end has two widely spaced bays. Symmetrically placed windows are 6/6 lights with corner block lintels and soldier course lintels. Two attic windows are 4 light fixed with corner block lintels. The east gable end has the same openings as the west but also is decorated with random glazed headers.

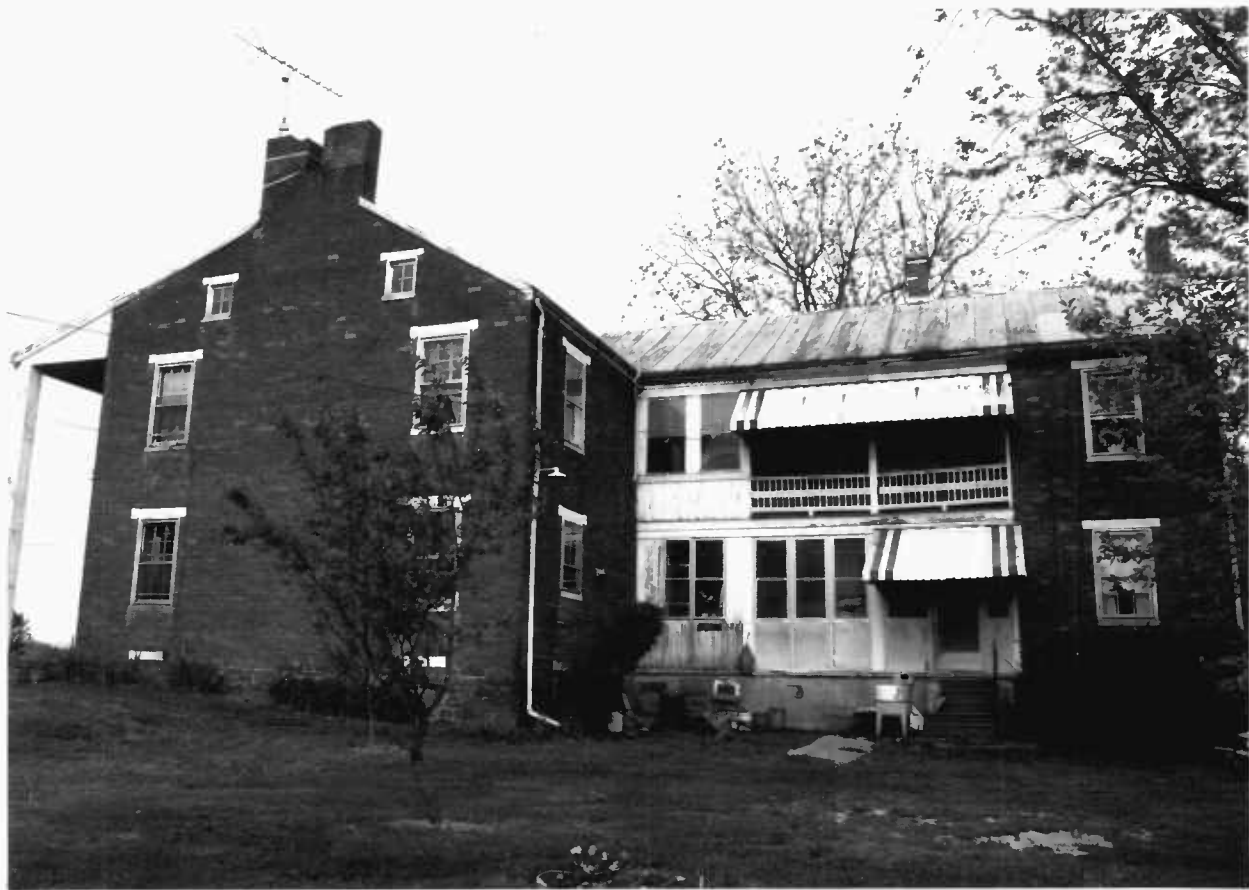
East elevation

The west elevation of the rear ell is 4 bays in length. Windows are symmetrically placed with 6/6 lights with corner block lintels. The east elevation has a recessed double porch that is three bays wide. It is enclosed with siding and metal. The last bay has 6/6 windows with corner block lintels. The north gable end is stuccoed. It has two 4 light fixed attic windows.

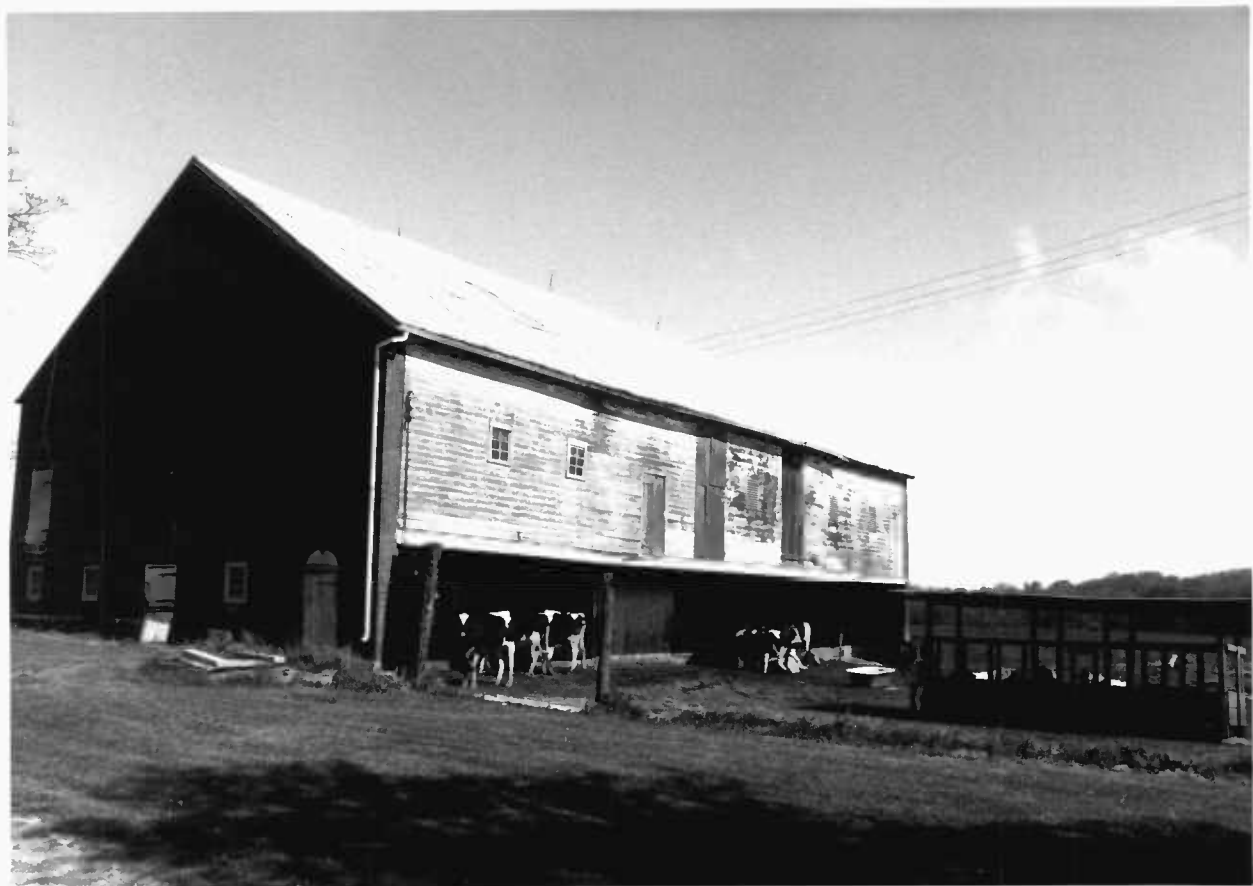
Bank Barn - Southeast corner view

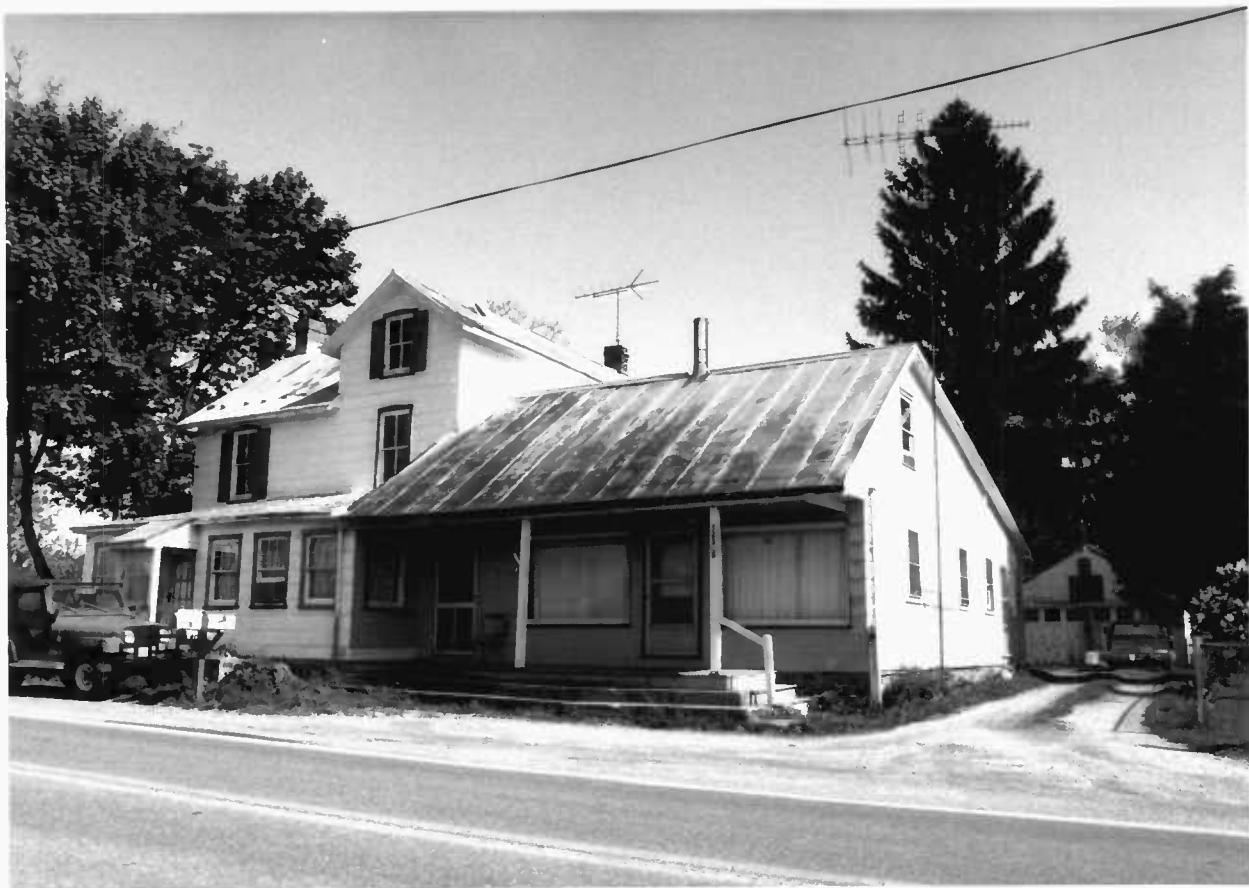
satn elevation
